**Flood Control Project Maintenance
Levee Inspections**

Fall 2011 Levee Maintenance Deficiency Summary Report

Sacramento River Basin

Levee Inspection Report By Mile - Fall 2011

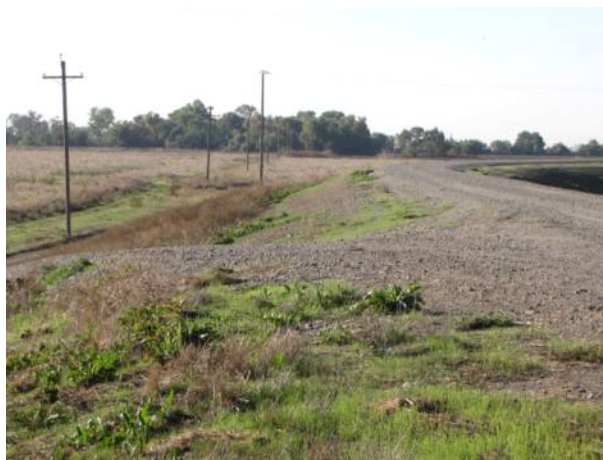
Levee Mile Report Line	1
Start Levee Mile	0.00
End Levee Mile	0.00
Location	Water Side
Category	Earthen Levee
Item	Vegetation

Levee mile 0.00 Putah Creek Unit 1. Photo taken 10-18-2011.

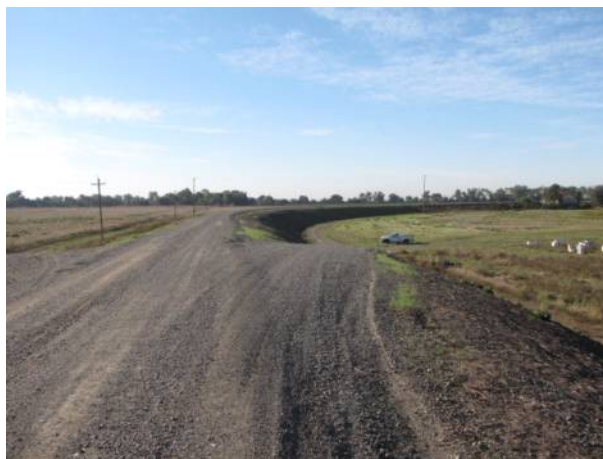
Levee Mile Report Line	2
Start Levee Mile	0.00
End Levee Mile	0.00
Location	Land Side
Category	Earthen Levee
Item	Vegetation

Land side levee mile 0.00 looking downstream Putah Creek. Photo taken 10-18-2011.

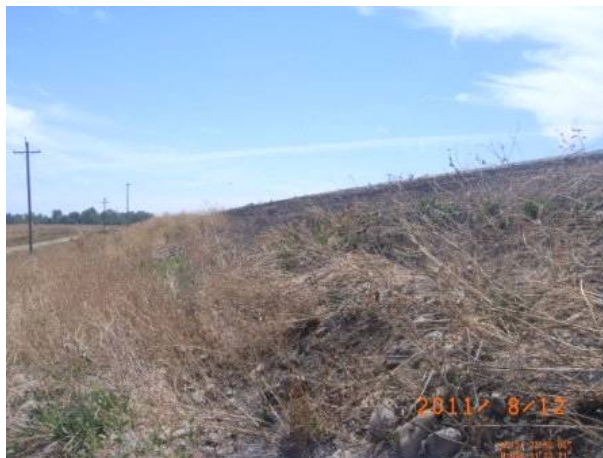
Levee Mile Report Line	3
Start Levee Mile	0.04
End Levee Mile	0.04
Location	Water Side
Category	Supplemental
Item	USACE Erosion Survey

USACE 2011 Photo #1

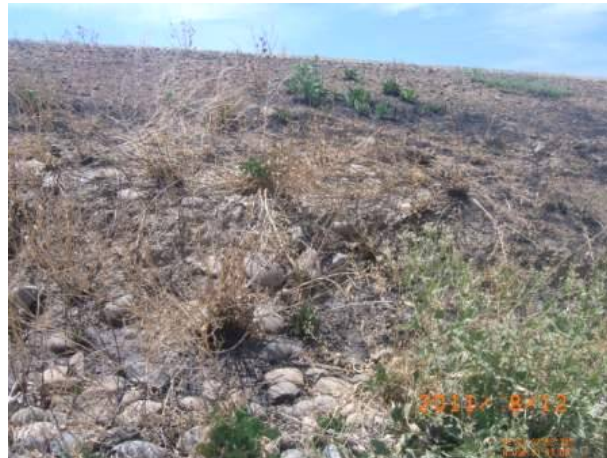
Levee Mile Report Line	3
Start Levee Mile	0.04
End Levee Mile	0.04
Location	Water Side
Category	Supplemental
Item	USACE Erosion Survey

USACE 2011 Photo #2

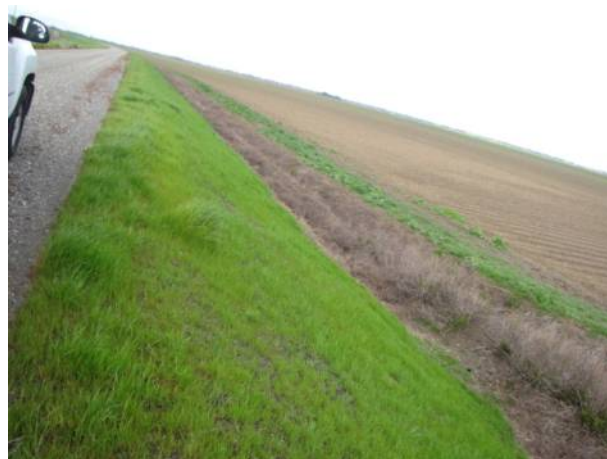
Levee Mile Report Line	7
Start Levee Mile	0.59
End Levee Mile	1.26
Location	Land Side
Category	Earthen Levee
Item	Encroachments

Agriculture Ditch within 10-foot of levee toe levee mile 0.59-1.26 land side Unit 1 Putah Creek. Photo taken 03-22-2011.

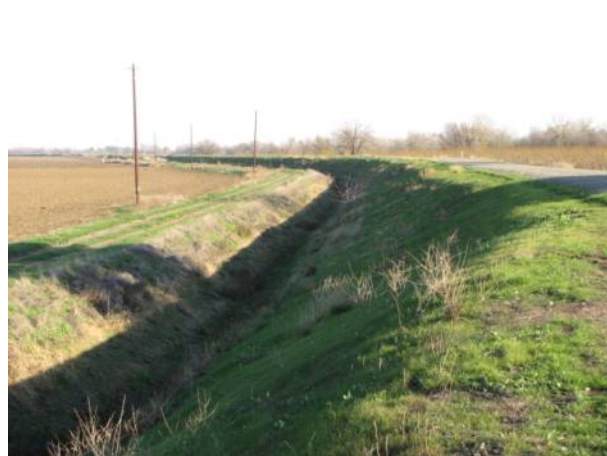
Levee Mile Report Line	8
Start Levee Mile	0.65
End Levee Mile	1.07
Location	Land Side
Category	Earthen Levee
Item	Vegetation

This ditch is located within the 10-foot easement and has been at this location for several years.

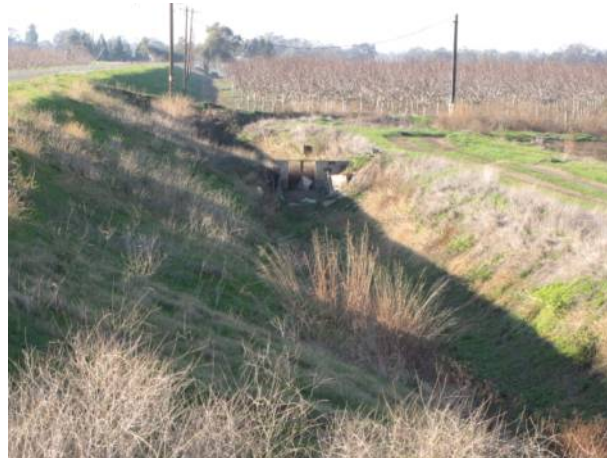
Levee Mile Report Line	8
Start Levee Mile	0.65
End Levee Mile	1.07
Location	Land Side
Category	Earthen Levee
Item	Vegetation
Another view of ditch looking downstream landward.	
phillips_f_20110929_218.jpg

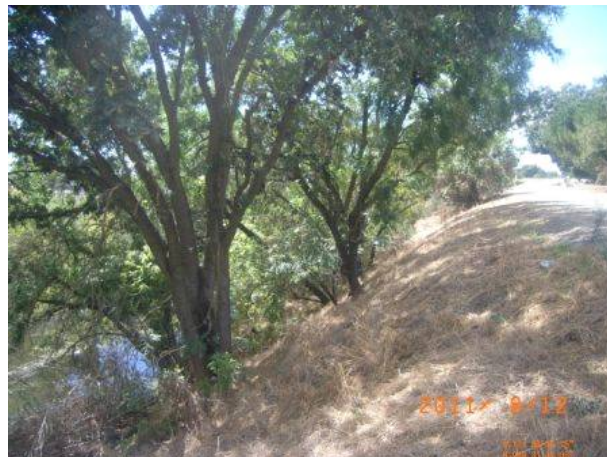
Levee Mile Report Line	15
Start Levee Mile	6.97
End Levee Mile	6.97
Location	Water Side
Category	Supplemental
Item	USACE Erosion Survey
USACE 2011 Photo #1	
USACE2011_PUC_7-2_L_1.jpg

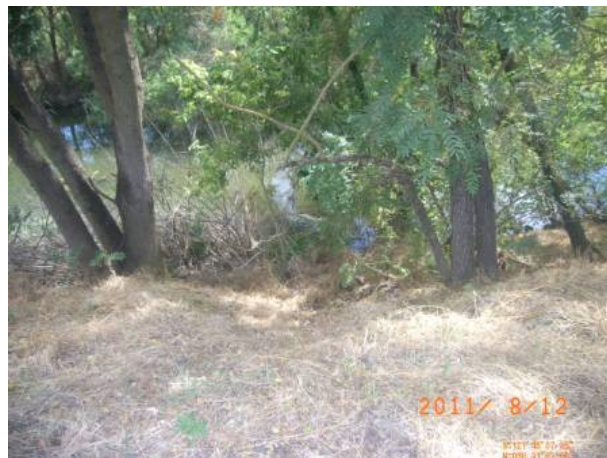
Levee Mile Report Line	15
Start Levee Mile	6.97
End Levee Mile	6.97
Location	Water Side
Category	Supplemental
Item	USACE Erosion Survey
USACE 2011 Photo #2	
USACE2011_PUC_7-2_L_2.jpg

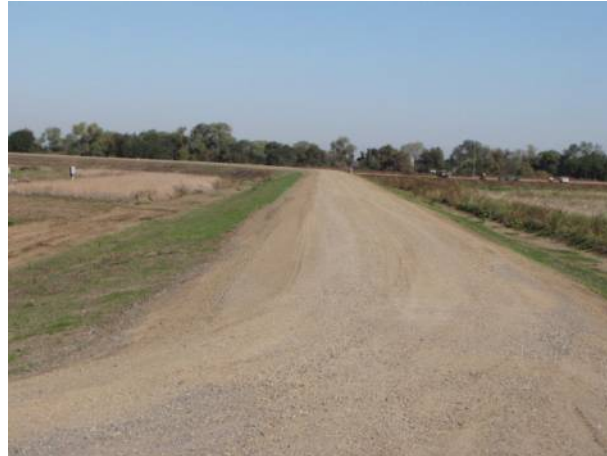
Levee Mile Report Line	1
Start Levee Mile	0.00
End Levee Mile	0.00
Location	Land Side
Category	Earthen Levee
Item	Vegetation
Levee mile 0.00 Unit 2 Putah Creek looking downstream. Photo taken 10-18-2011.	
phillips_f_20111018_023.jpg

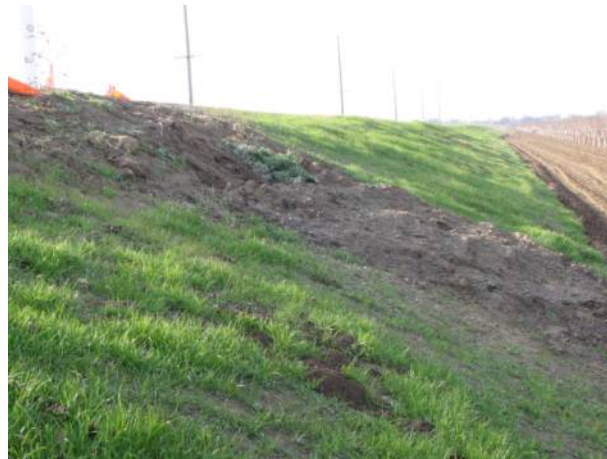
Levee Mile Report Line	5
Start Levee Mile	1.09
End Levee Mile	1.10
Location	Water Side
Category	Earthen Levee
Item	Erosion / Bank Caving
Photo shows partial repair of slope damage.	
phillips_f_20110929_220.jpg

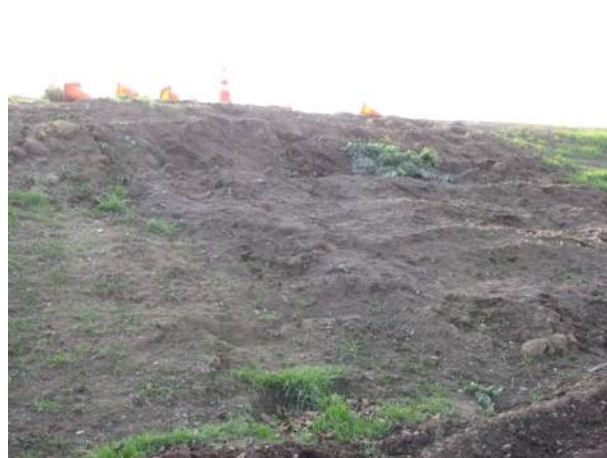
Levee Mile Report Line	5
Start Levee Mile	1.09
End Levee Mile	1.10
Location	Water Side
Category	Earthen Levee
Item	Erosion / Bank Caving
slope damage some repairs made. Proper repair need to be done at this site with compaction test to verify compaction.	
phillips_f_20110929_221.jpg

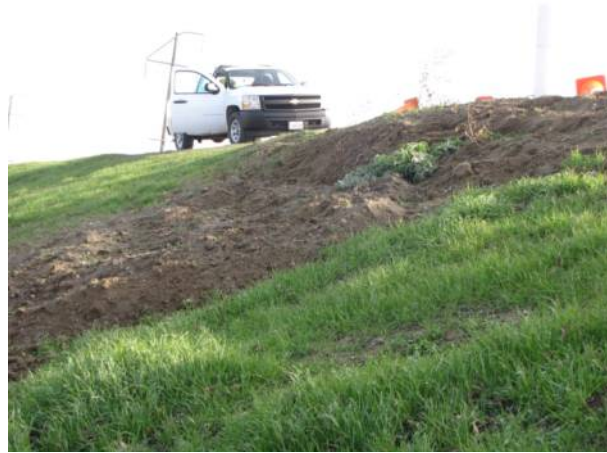
Levee Mile Report Line	5
Start Levee Mile	1.09
End Levee Mile	1.10
Location	Water Side
Category	Earthen Levee
Item	Erosion / Bank Caving
Another view standing on toe of slope looking upstream.	
phillips_f_20110929_222.jpg
